Manhole Inspection Summary

Manhole # S37A__010MH

Inspection ☐ Is Incomplete Rating: **3) Fair**

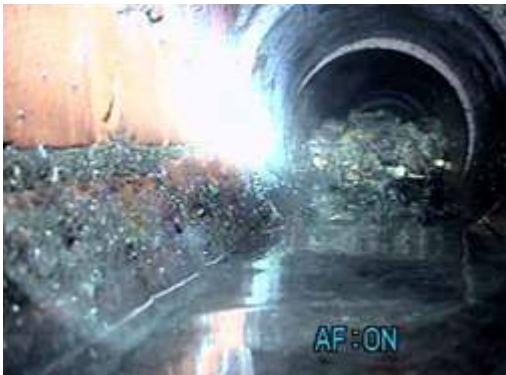
Misc

closer view of inside seal of pipe 7

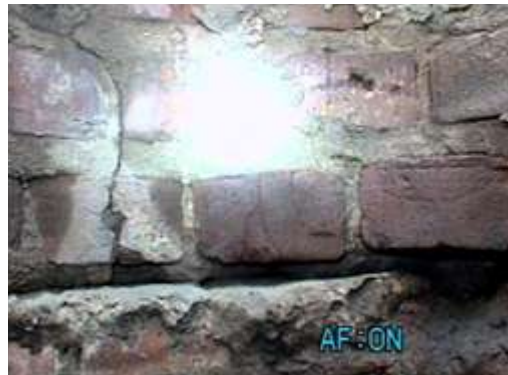
Defect 2

Condition: ☐ Sound ☒ **Cracked** ☐ Root Intrusion ☐ Loose Brick ☐ Deteriorated

chimney cracked

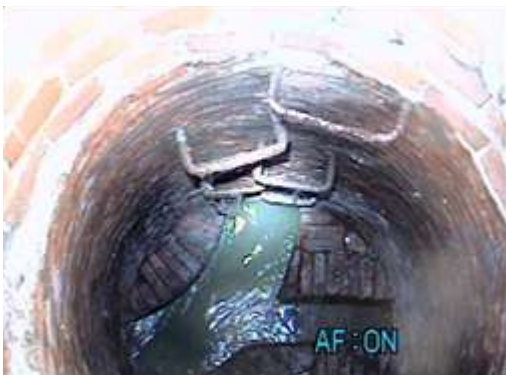
Defect 1

Count: **5** Missing: **0** ☒ **Corroded**

steps corroded

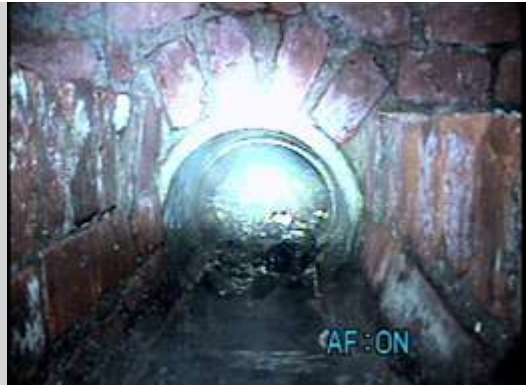
7 O'Clock Inflow

Infiltration: **None** Pipe Seal Cond: **Cracked**
